Overview

Introduction

This report presents the results of a field reconnaissance conducted by EPA Region 10's Office of Environmental Cleanup in coordination with the Office of Environmental Assessment. The purpose of the study was to determine if asbestos was present at a site where a former quarry now abuts a residential development.

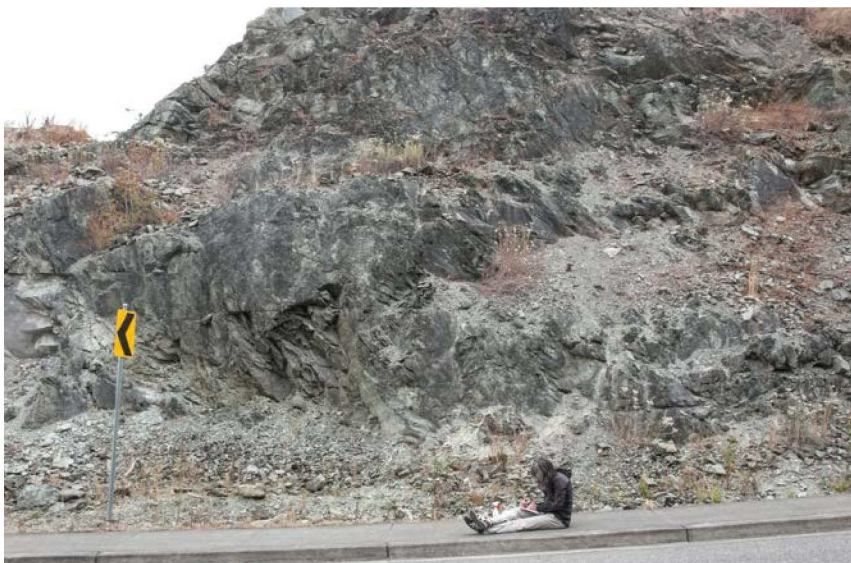
Starting at the northwest entry to the Burlington Hill development, the first samples were collected from a road cut on Hillcrest Drive, just as the road begins to climb uphill. We moved from downhill to uphill along the road cut and sampled three separate sample sites (see Table 1), but ~~these are y should be~~considered one sample location ~~overall~~.

The rock throughout the road cut is a highly fractured green schist. Some zones are lighter than others and have a talc consistency.

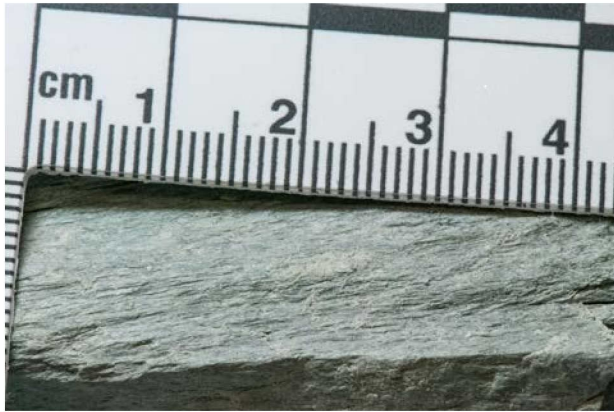
The image above is from the **farthest** downhill sample for MEL (12090101). Some minor quartz veins are apparent in the hand sample, but nothing obviously fibrous. Material is weathered, fine-grained, light green, and has a talc or soapstone consistency. The texture of the rock is slaty and with no apparent fibers, but there are some small needle-shaped crystals. **that might meet the definition of fibers.**

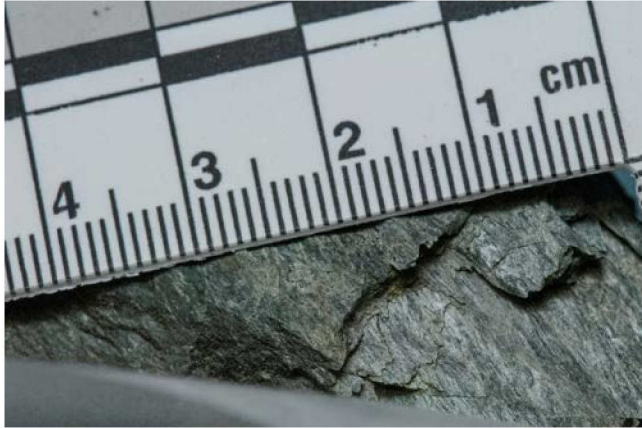
The image above is the platy rock collected as MEL 12090103.

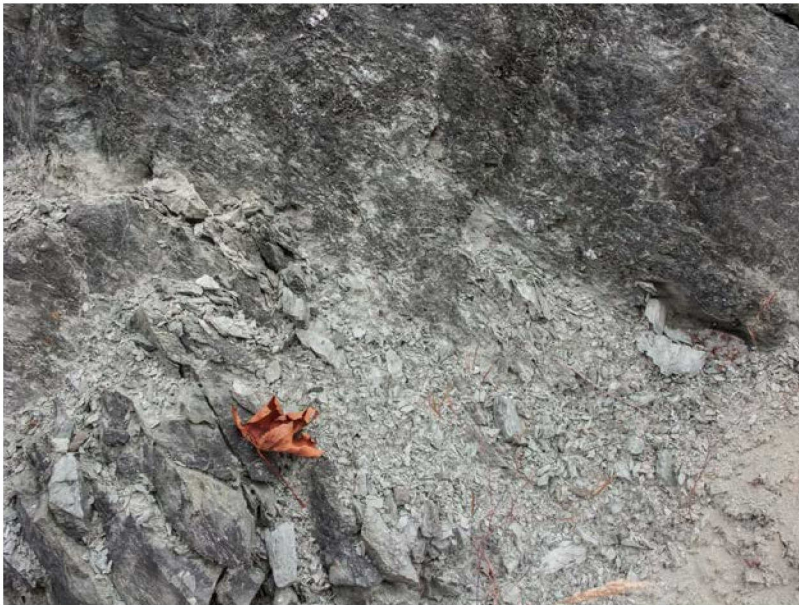
The most uphill sample from the same road cut is for PLM (12090105). This is from some more weathered material, pale green, with a shaly texture and fractures that contain what seems to be a fibrous material, with needle-like structure. This sample was from the uphill edge of the outcrop, just below the cement block retaining wall.

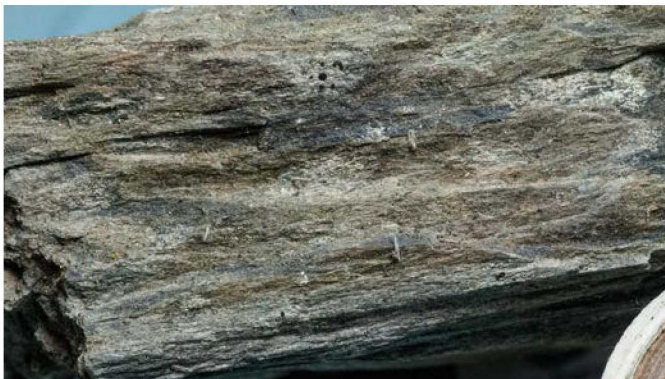
These samples are from a residence on Tinas Coma Drive. The first is from an outcrop to the left of the upper garage door (south of driveway). The rocks here are striated, weathered, and have a sort of "woody" texture from a distance (sample 12090106).

In the hand sample, the texture is very platy and, contains needle-like crystals ~~that could be fiber bundles~~.

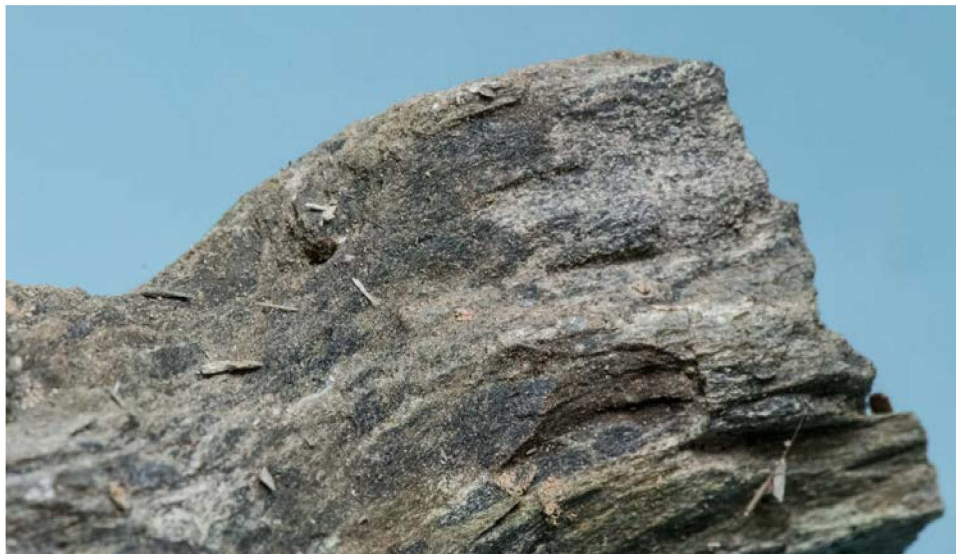
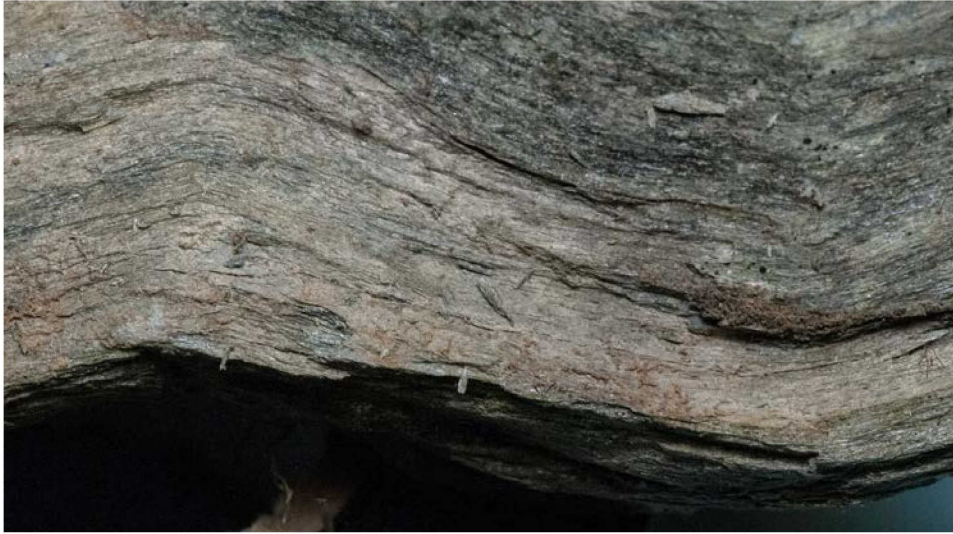
The PLM sample collected has some organic matter (12090107). This sample does not show obvious fibers, but has a needle-like texture locally, although most of the rock is platy.

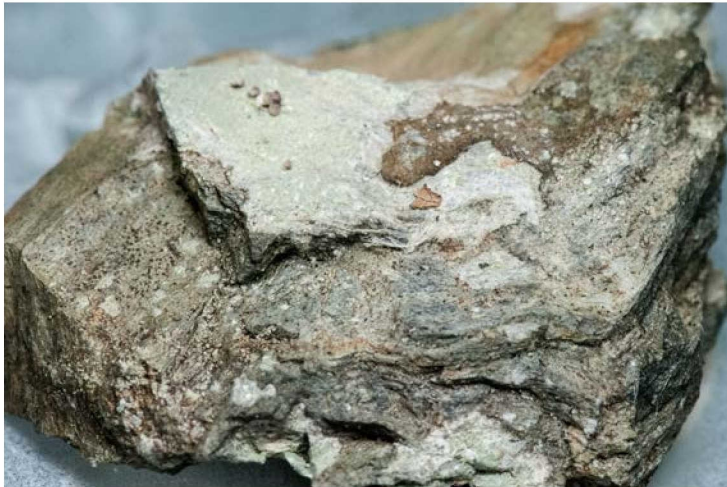
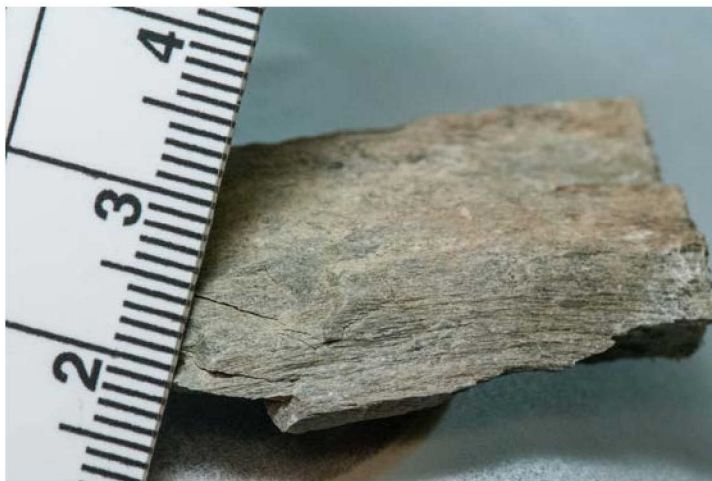
The next sample was collected adjacent to the garage, on the left side (west) of the driveway. The light green material was observed and one surface looks very fibrous.

The sample (12090108) collected was farther along driveway, at the garage corner. A fractured surface shows the fibrous material visible with a hand lens.

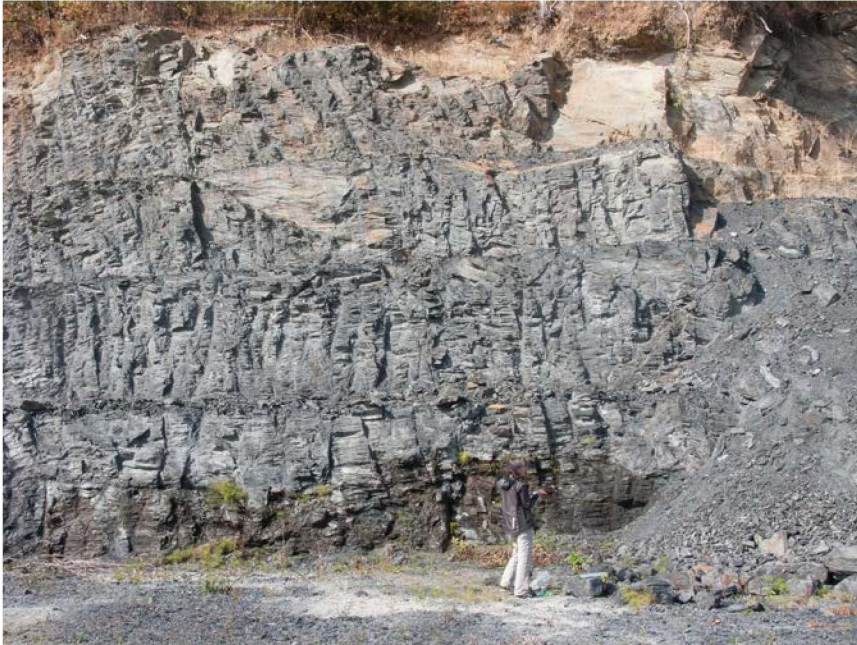
This is reportedly the old quarry site, and contains remnants from some site preparation for planned condos that were never built. The rock along the back wall is dark gray, almost black, has a slaty texture, but is competent enough to hold a nearly vertical slope.

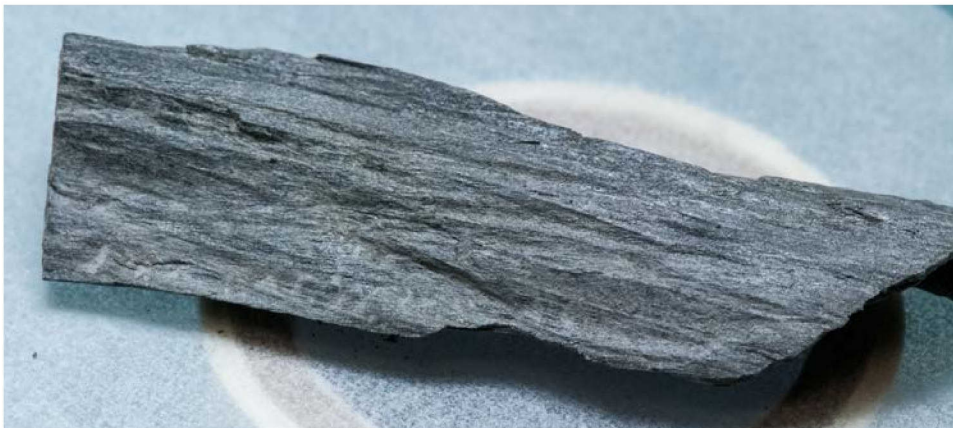
The right end of the wall (north) is our first sample location (12090110). There is no obvious veining or fibers or even needles, and not even much of the gray-green altered rock at this location, although both the north and south ends have a little more weathering or alteration. There is no evidence of the talc that was reportedly mined here. A few quartz veinlets are present. The hand sample is dark gray, very foliated, with no visible fibers.

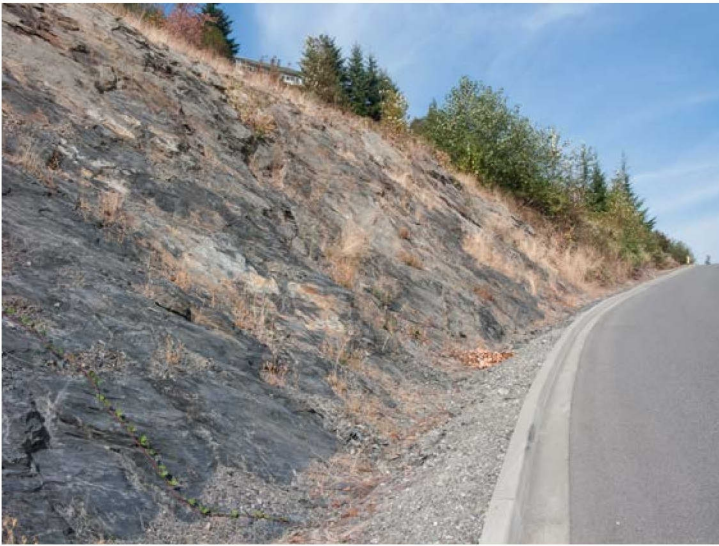
The final location was the road cut at the neighborhood entry on southeast side of Burlington Hill.

Here the rocks look similar to those seen at Location 3. The light gray-green color or the talc consistency layers observed at Location 1 were not observed here. The rock is more competent and also **has-contains** some of the quartz veinlets. At the end of cut (uphill), some of the altered greenish rock with **possible** needle-like structures along fractures was observed and sampled (12090113, see below). Note that this sample was not under custody the entire time prior to analysis. The rock is dark gray and shaley, and not visibly fibrous, but the thin green fractured surface could be different. No fibers were visible with hand lens, **thoughhowever**.

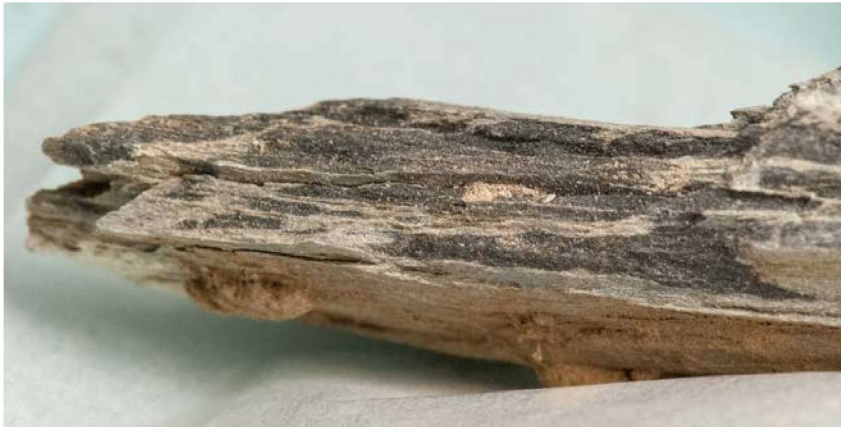
Another sample (12090114) was collected from north (uphill) end of the road cut. A final sample was collected at south end of cut (12090115). Nothing fibrous was observed in the hand sample.
